WORLD TRADE CENTER ARCHIVE
INTERIM STORAGE FACILITY,
JFK INTERNATIONAL AIRPORT

PRESERVATION AND INVENTORY REPORT

Draft 2: November 8, 2002

Prepared by:
VOORSANGER & ASSOCIATES ARCHITECTS, PC
246 WEST 38th STREET, NEW YORK, NY 10018
Tel. 212. 302. 6464

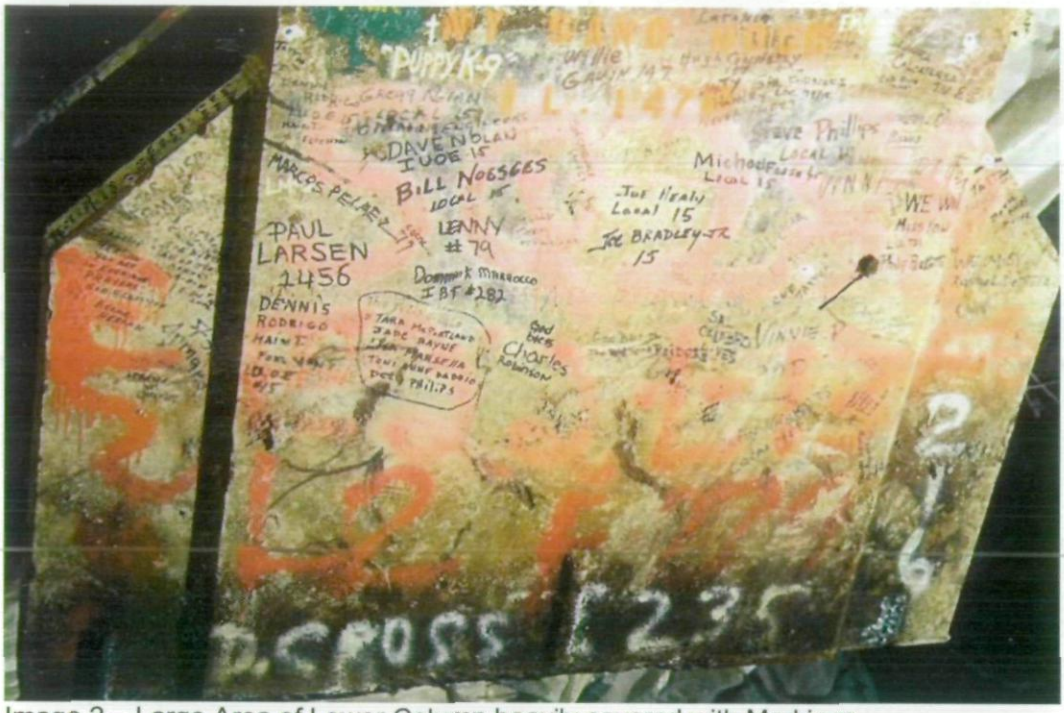
Image 2 – Large Area of Lower Column heavily covered with Markings

Image 3 – Evidence of Large Areas of Fragile Rust Under Paint

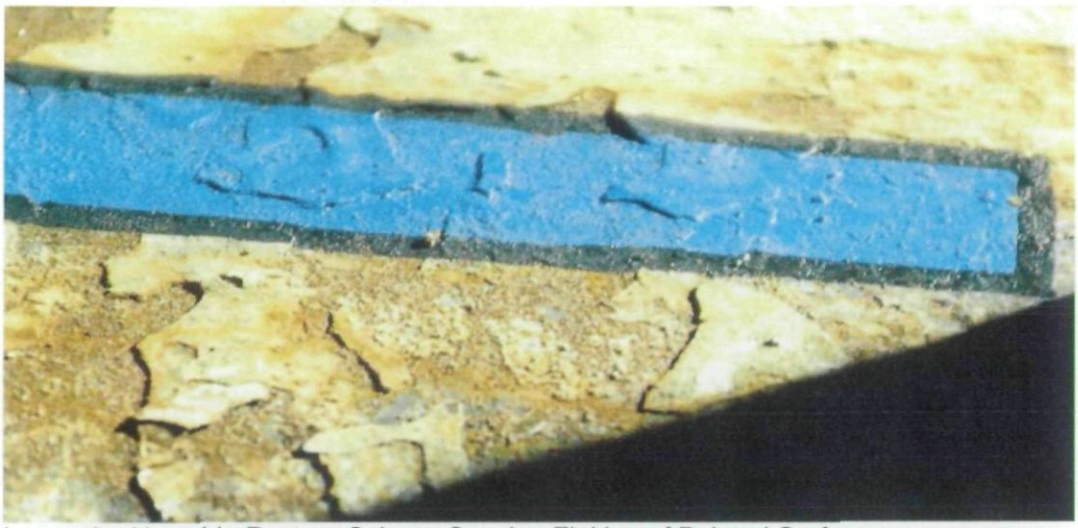
Image 4 – Unstable Rust on Column Causing Flaking of Painted Surfaces

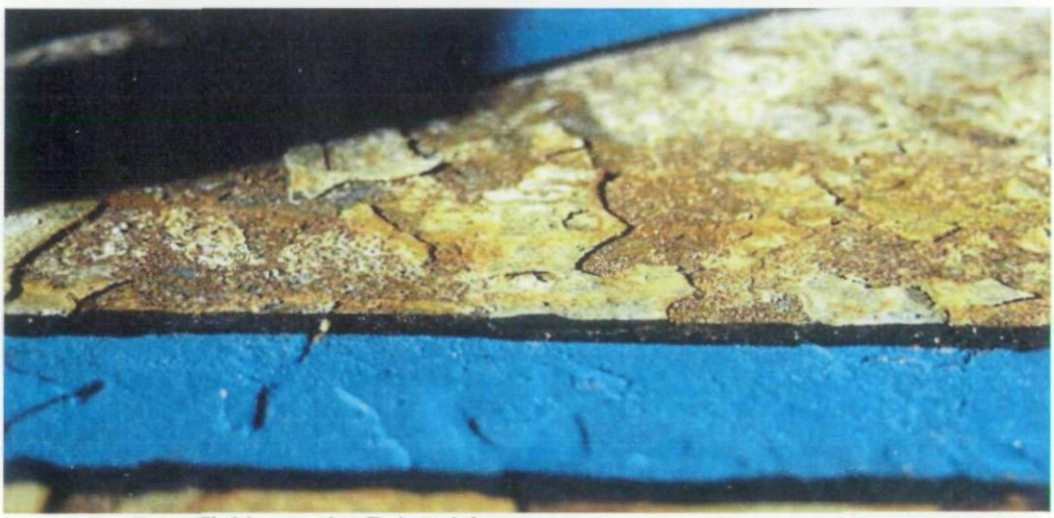
Image 5 – Rust Flaking under Painted Areas

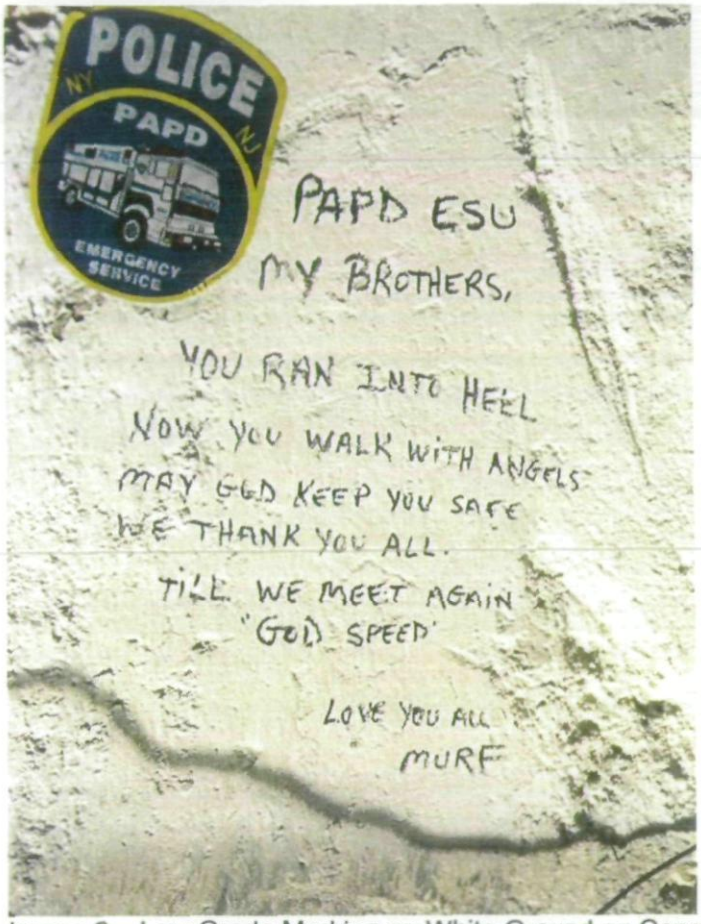
Image 9 – Low Grade Marking on White Ground on Concrete with High Potential for Further Loss

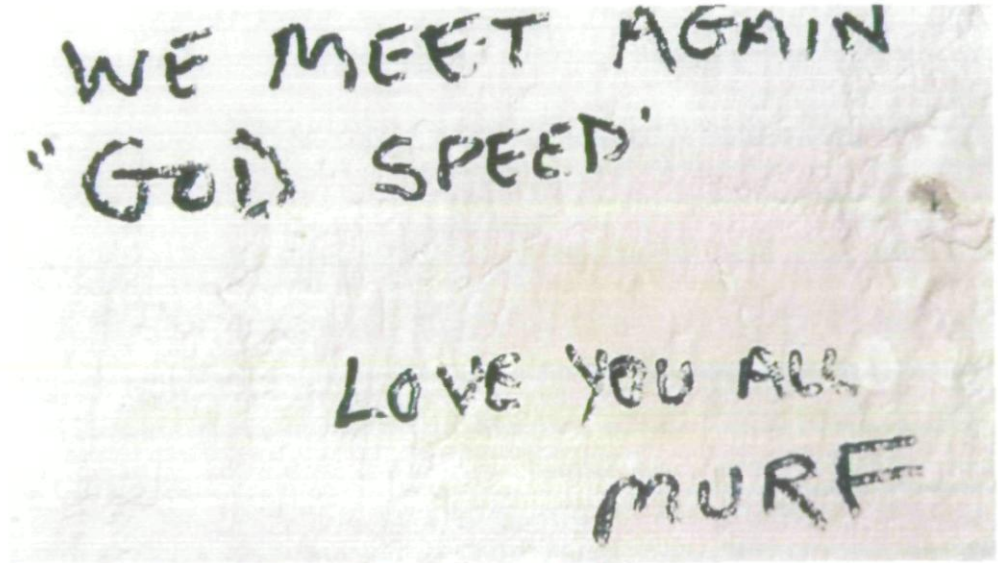
Image 10 – Loss of Markings from Personal Writings

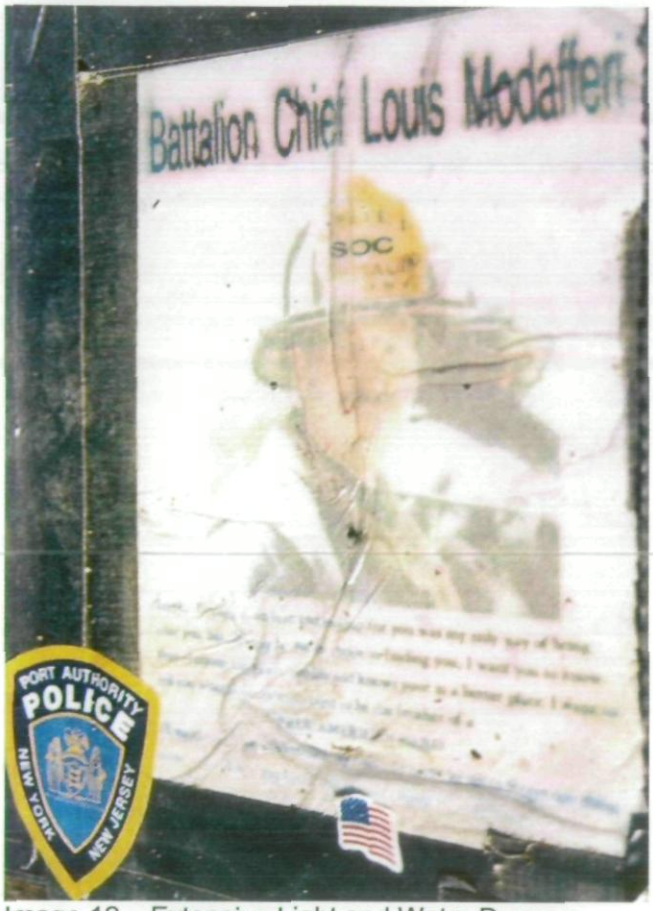
Image 12 – Extensive Light and Water Damage

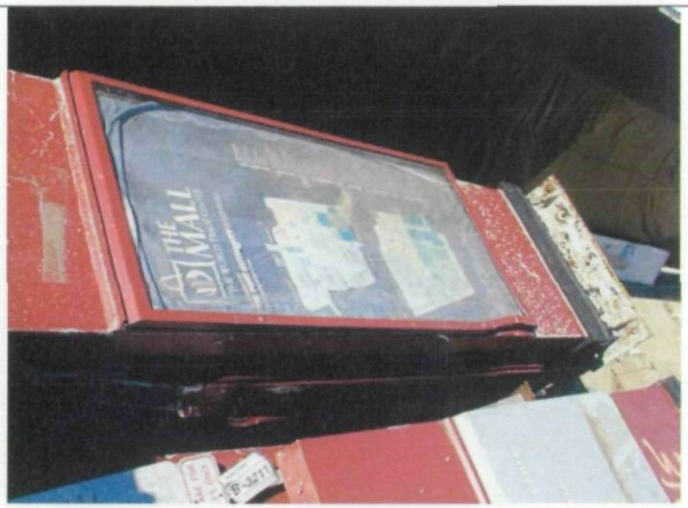
Section B-3000: Building Components	**B-3205**
Item: Signage: "The Mall at The World Trade Center" Dimensions: 12ft.L x 4ft. x 2ft. H	
* Architect and Conservation Team request special consideration of paper debris associated with this object.

Decontamination Notes: Contractor please consult Architect and Conservation team to discus possible methods for consolidation and preservation of debris prior to any action.	
Decontamination Category: **4**	PA080007.jpg 10/08/02

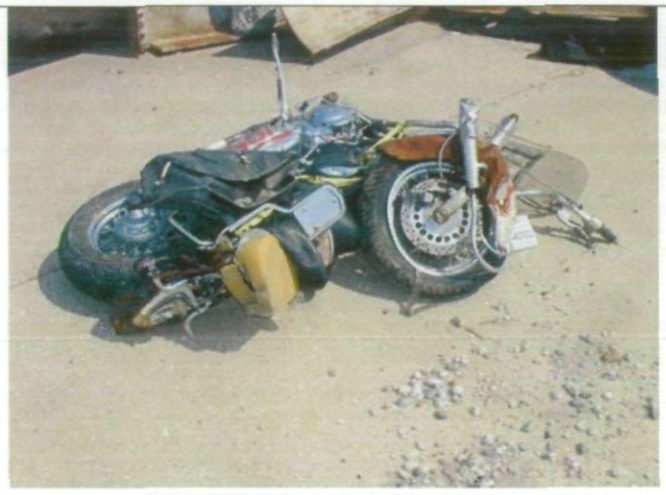
* Architect and Conservation Team request special consideration of this artifact.

Decontamination Notes:
Contractor please consult Architect and Conservation team to discus possible methods for decontamination and preservation of debris prior to any action.

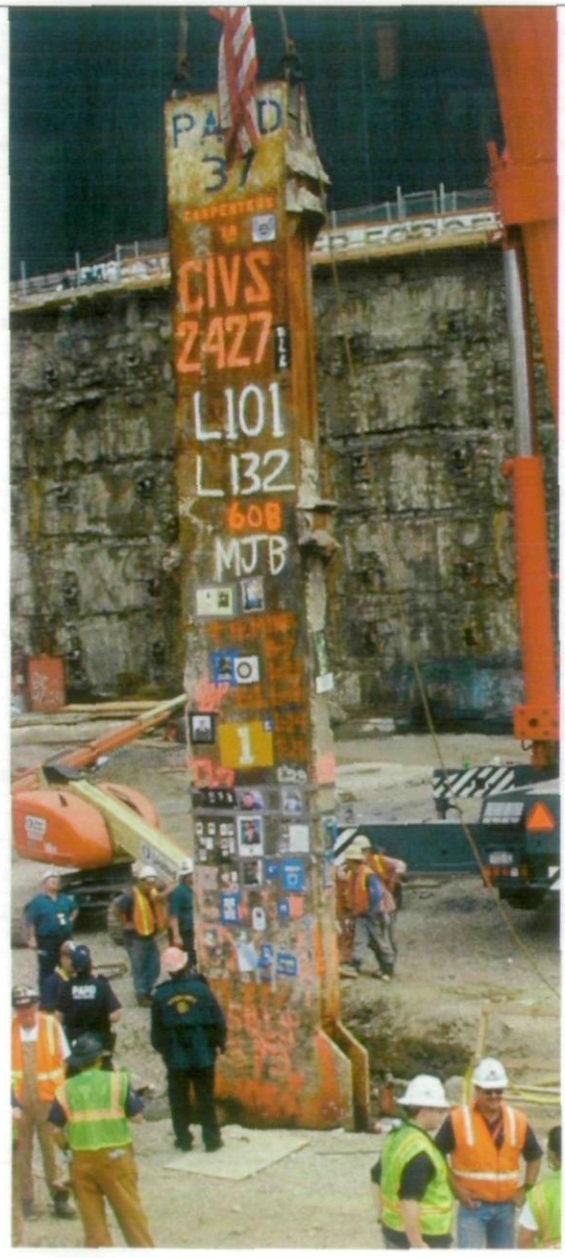
Item: Last Column

In spite of the size and solidity of this column, the graffiti covered surface and attached paper objects are extremely fragile, and are likely to be irreparably damaged if not properly protected. The following comments address immediate procedures for how to preserve the surface and fragile objects. Listed first and foremost are concerns regarding how the column should be handled and displayed.

Given the present condition of the column's surface, physical handling will inevitably result in some level of damage to the surface. Already, there is damage to the surface, some from the time of exposure on site after workers wrote on the column, and some from the move to JFK. Although the people involved in the move were very careful, it was almost impossible to avoid some level of damage in the process of handling and transporting the column to JFK. Even to move the column one more time to another part of the hangar requires careful planning as to where to place supports, etc.

- There are many areas of column graffiti that will be damaged from extended exposure to water, especially when combined with the physical action of wiping or moderate pressure power washing. Specifically, something as important as the "Murf" inscription on the side of the column (see photograph) will be damaged because it is written on a soft, poorly consolidated ground layer. In fact, this inscription already exhibits extensive damage. Further damage will destroy a critical aspect of the column's power as a historical marker and memorial. Depending on the cleaning method selected, it will be necessary to avoid all these extremely vulnerable areas.

Decontamination Notes:
*NOTE: See the "Preservation Report", included, for special recommendations.

To reduce risk of damage in the future when the column is moved, a number of steps must be taken.

- All attached materials such as pictures and posters must be removed, and a system must be devised for their temporary reattachment (either of original materials or reproductions – further described below).
- All loose areas of paint will require some measure of consolidation.
- Locations where the column will be handled must be carefully determined so that surface abrasion from support elements will not damage critical or "at risk" surfaces.

- From the perspective of preserving the column's graffiti over the long term, we do not recommend the application of an encapsulating resin. If, for reasons of health and safety, an isolating resin must be applied, the option and choice of resin must be carefully considered. Over the last hundred years, many objects have been damaged by the injudicious application of a resin coating that was intended to protect the surface.

For all the reasons described above, it is important to determine if the column should be decontaminated by pre-testing. A decontamination method should be selected that minimizes risk to the surface. Treatment of very delicate areas should be avoided entirely, especially if there is no evidence of contamination. In order to do a safe treatment, we recommend that the conservation team in conjunction with the team that will do the decontamination carry out some initial test cleaning together prior to the actual work so that a mutually satisfactory procedure can be developed.

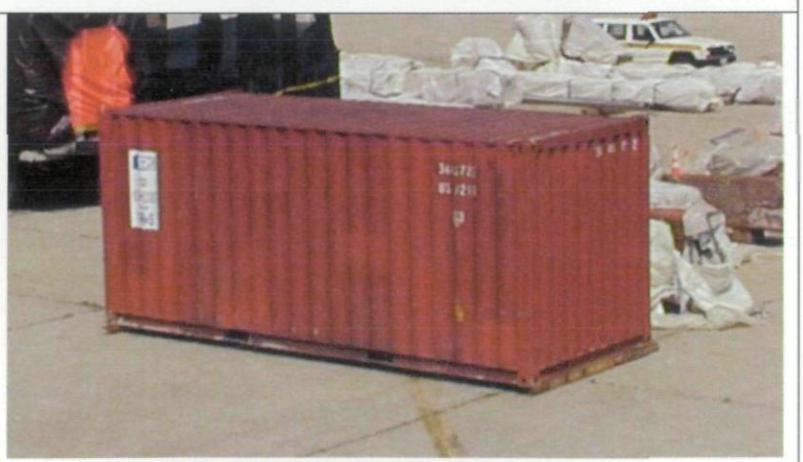
Section X-0000: Temporary Catalog Numbers	**X-0002**	
Item: Unknown Contents of Steel Waste Container Dimensions: 15ft. L x 6ft. W x 9ft. H		
* Architect and Conservation Team request special consideration of this artifact.

Decontamination Notes: Contents unknown. Inspection required prior to decontamination Contractor please consult Architect and Conservation team to discus possible methods for decontamination and preservation of debris prior to any action.		
Decontamination Category: **5**	P1010034.jpg	8/7/02
